## IMAGE FOCUS

## Apico-aortic valved conduit for the treatment of severe aortic stenosis and porcelain aorta

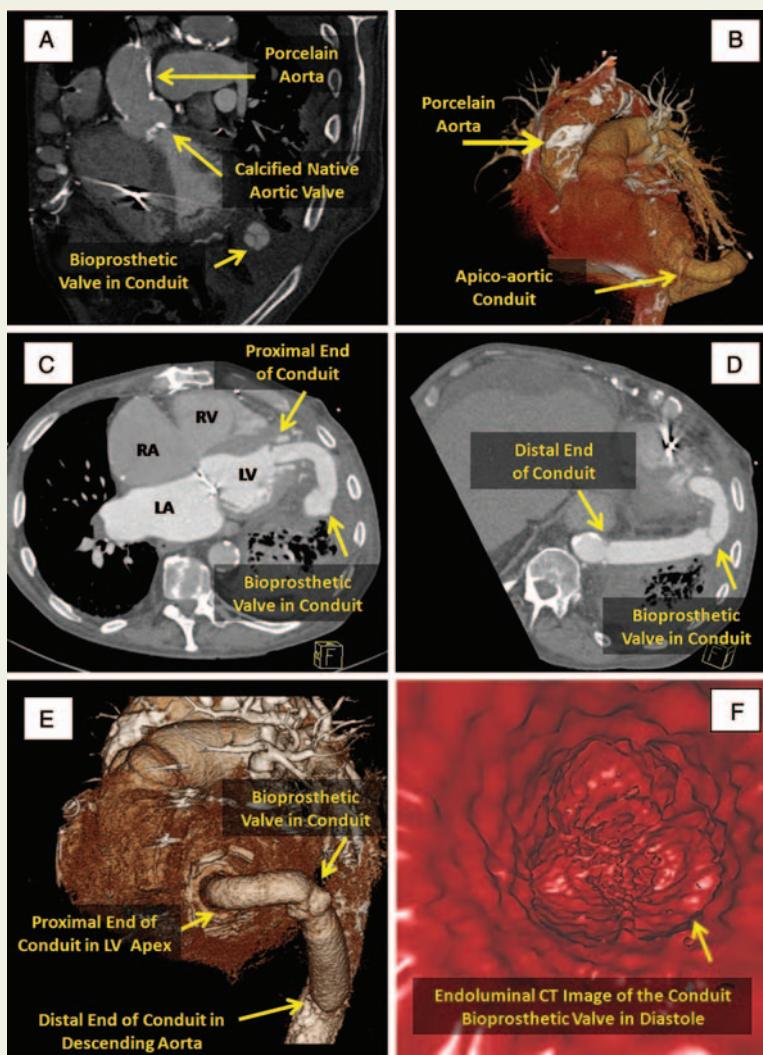
Thoracic computed tomography (CT) showed severe and diffuse calcifications of the thoracic aorta ('porcelain aorta'; *Panels A and B*) which precluded standard surgical aortic valve replacement (AVR) using aortic cross clamping. He was then considered for a transcatheter aortic-valve implantation (TAVI); however, his aortic annulus was too large for TAVI.

Instead, he underwent successful on-pump implantation of an LV apex to the descending thoracic aorta conduit with a porcine bioprosthetic valve (Freestyle®, Medtronic, Inc.). Postoperative contrast-enhanced cardiac CT with retrospective gating demonstrated the proximal end of the conduit inserting normally into the apical lateral wall (*Panel C*), and the distal end into an area of the descending thoracic aorta relatively spared from severe atherosclerosis (*Panels D and E*, see Supplementary data online, *Video S2*). Inside the conduit, the bioprosthetic valve leaflets (*Image F*) were seen opening and closing normally (see Supplementary data online, *Video S3*).

Transthoracic echocardiography demonstrated the left ventricular (LV) ejection fraction of 35%, severe tricuspid regurgitation, calcified trileaflet aortic valve with severe stenosis (see Supplementary data online, *Video S1*), and a valve area of 0.6 cm<sup>2</sup>. The peak and mean gradients were 60 and 34 mmHg, respectively.
