## IMAGE FOCUS

## Multimodality imaging of an inadvertently placed defibrillator lead in the left ventricle

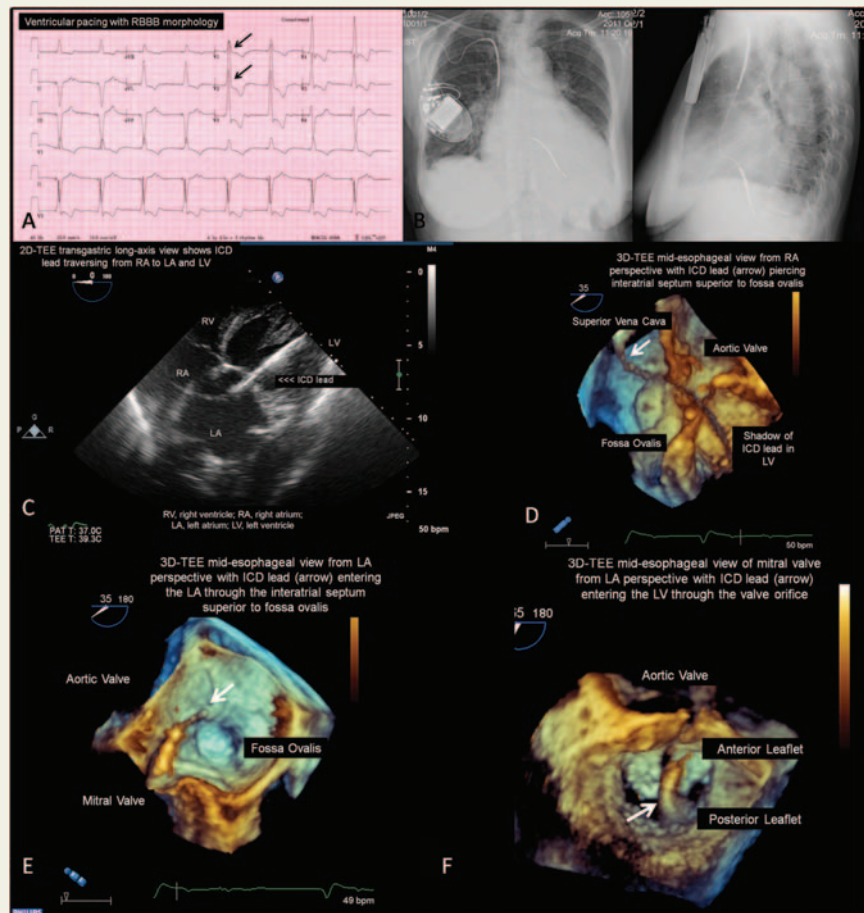
A 77-year-old woman with a history of internal cardiac defibrillator (ICD) placement 5 years earlier was referred for transoesophageal echocardiography (TOE) to evaluate mitral regurgitation. An electrocardiogram revealed ventricular pacing with unexpected right bundle branch morphology (Panel A). On chest X-ray, the lead terminated in the left ventricular (LV) apex (Panel B).

Two- and three-dimensional TOE revealed an ICD lead entering the right atrium via the superior vena cava, perforating the interatrial septum just superior to the fossa ovalis resulting in an iatrogenic atrial septal defect (see Supplementary data online, *Video S1*), coursing through the mitral valve orifice and terminating in the LV (Panels C–F; see Supplementary data online, *Video S2*). There was severe mitral regurgitation.

Malposition in the LV is a known complication of transvenous insertion of pacing leads, the incidence of which is unknown. Its most common complication is thrombo-embolism. Treatment includes anticoagulation and lead extraction with repositioning in the right ventricle.
