Ultrasound imaging artifacts: How to recognize them and how to avoid them

Mary M. Quien MD

| Muhamed Saric MD, PhD

Leon H. Charney Division of
Cardiology, New York University Langone
Health, New York, New York

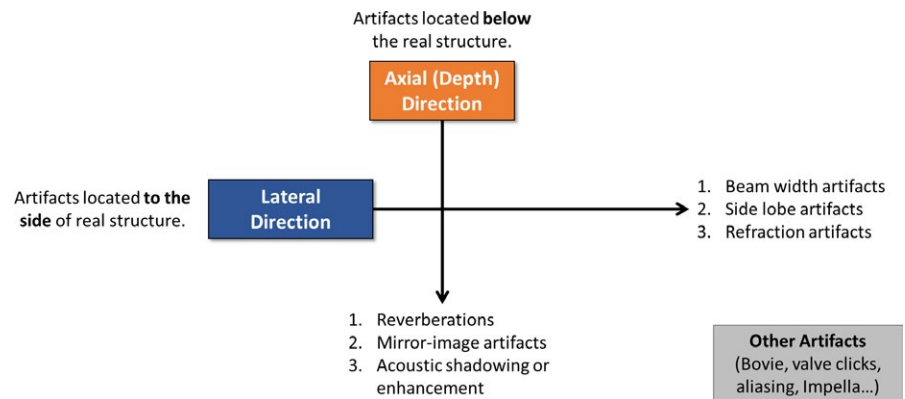
FIGURE 1 Cartoon depicting categories of assumption violation artifacts based on location relative to the true image

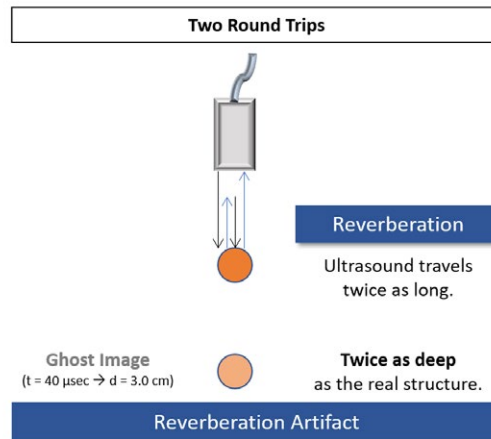
ASSUMPTION VIOLATION What happens when the time measured represents more than a single round trip?

FIGURE 2 Cartoon illustrating the ultrasound assumption and how violation of this assumption results in the reverberation artifact

The reverberation artifact violates the assumption that an echo returns to the transducer after one reflection. In theory, when the ultrasound wave is emitted from the transducer, it interacts with surface of the structure, and the reflected wave is transmitted directly back to the transducer, making a single round trip (Figure 2). In reality, the reflected ultrasound wave can encounter a closer reflector on its way back to the transducer. One portion of the wave travels back to the transducer as expected, while the other portion is instead reflected back to the original structure.

The portion that was caught by the second reflector essentially makes a second round trip by traveling back to the original structure before eventually making it back to the transducer. Because the ultrasound system assumes that the wave only makes one round trip, the transducer interprets this longer travel time as a reflection coming from a structure that is further away than the original structure. Thus, the transducer produces an artificial image below the original structure at twice the distance between the transducer and the structure (Figure 3). Parallel motion at this distance can usually be seen and is a good indicator of this artifact. The second reflector is often the transducer itself, but can also be other common reflectors, such as the aorta, calcified structures, and implanted devices.⁴

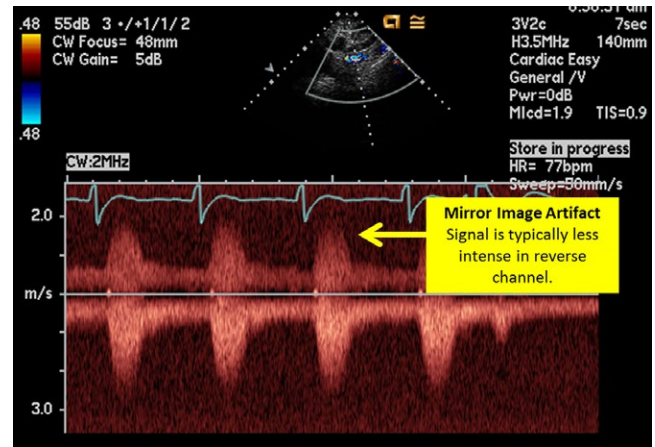
FIGURE 8 Mirror image artifact shown in Doppler of the subclavian artery of a patient with a functioning left-arm dialysis shunt

When mirror artifacts lead to misdiagnosis, they are often found leading to confusion about the flow in two adjacent vessels in spectral and color Doppler (Figure 8). For example, in patients with mitral valve prostheses, mirroring of the left ventricular outflow tract flow (LVOT) can result in misdiagnosis of MR. One group observed that in patients with tilting disk mitral valve prostheses, color Doppler images from transthoracic echocardiography (TTE) apical views, which suggested significant MR, differed greatly from images from TEE or angiography, which showed only trace physiologic MR.²⁶ Another study examined a similar cohort and found that 12% had a discrepancy between echocardiographic and operative findings of the degree of MR. In 3.4%, no abnormalities were found at the time of operation even though they had a preoperative echocardiographic diagnosis of prosthetic dysfunction.²⁷ These studies thus show that a misdiagnosis of MR can be problematic, leading to further evaluation, more imaging, and even unwarranted cardiac catheterization or surgery.

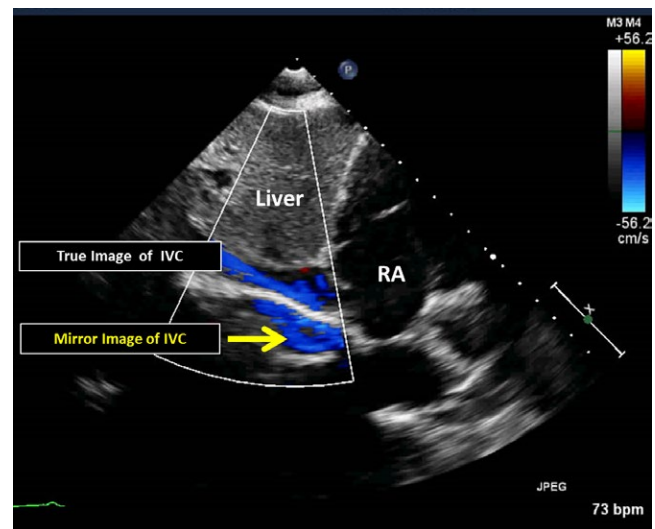
FIGURE 9 (Corresponds to Movie S6). Mirror artifact producing an inverted inferior vena cava (yellow arrow). RA = right atrium

Mirror artifacts can also complicate the evaluation of major vessels. For example, the artifact can produce a complete vessel duplication (Figure 9), which can confound sonographers' interpretations of the subclavian region.²⁸ These artifacts have also been commonly found in the carotid arteries and have led to problems in diagnosing stenosis and plaques.²⁹ One of the most important consequences of misinterpretation of this artifact is a false diagnosis of dissection,

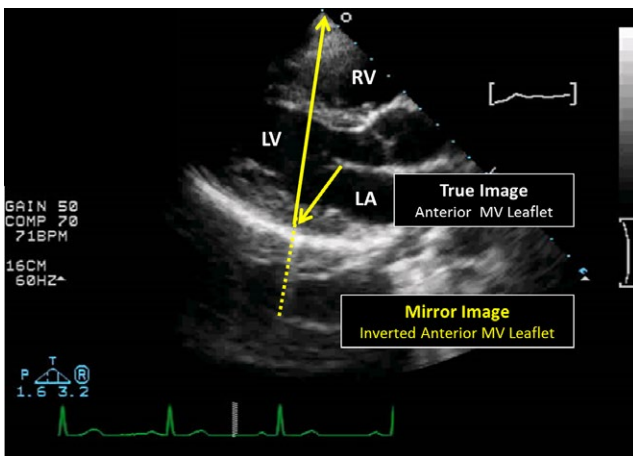
FIGURE 7 (Corresponds to Movie S5). Trajectory of the ultrasound wave as it travels back to the transducer (solid line), bouncing off a reflective object and producing a mirror artifact of the anterior mitral valve leaflet (dotted line). LA = left atrium; LV = left ventricle; RV = right ventricle

The mirror image artifact violates the assumptions that the ultrasound wave moves in a linear path and that the echo returns to the transducer after a single reflection. In this scenario, the ultrasound wave from the transducer is initially reflected from the desired object at an angle (angle of reflection = angle of incidence) and then encounters a highly reflective structure that is between the transducer and the initial object (Figure 7). The wave then travels back to the initial object before traversing to the transducer. The transducer does not recognize that the wave took an indirect path on its way back. Instead, it assumes that the longer travel time indicates that the intervening structure must be along a straight path below the initial object, and thus maps a false image of the intervening structure as such. The false image acts as a mirrored object: inverted and moving in the opposite direction as the true intervening structure. These artifacts are usually easy to identify as one can usually see both the original structure and its mirror image in the same frame.

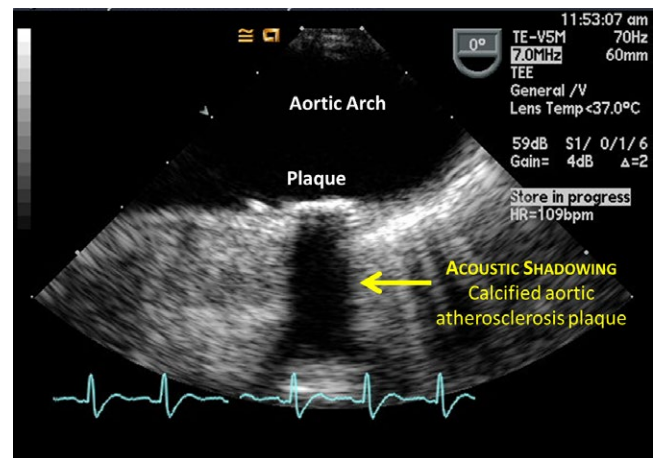
FIGURE 10 (Corresponds to Movie S7). Calcified aortic atherosclerosis plaque causing acoustic shadowing artifact (yellow arrow)

Acoustic shadowing (Figures 10 and 11) can be found with any calcium-containing structure, prosthetic valves, and even silicone breast implants. This artifact has been known to be particularly problematic in evaluating paravalvular leaks in patients with prosthetic valves due to shadowing from the prosthesis material.³³ The anterior feature of the aortic ring is especially difficult to visualize because of shadowing from the posterior valve ring.³⁴

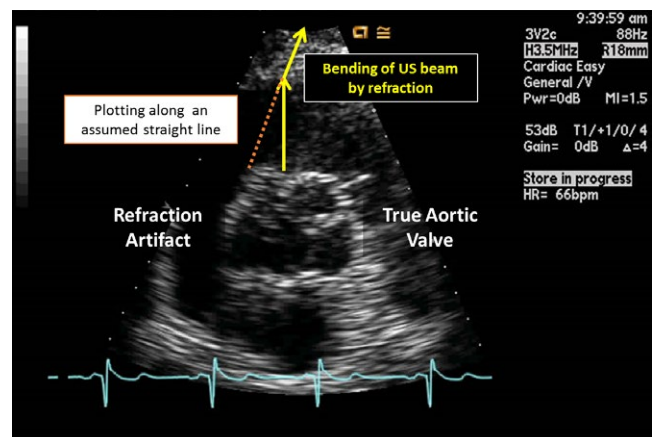
FIGURE 13 (Corresponds to Movie S10). Demonstration of the altered path of the wave (dotted line), leading to refraction artifact showing duplication of the aortic valve

The refraction artifact violates the assumptions that the path of the ultrasound wave is straight and that the speed of the ultrasound wave is uniform. In this scenario, instead of the ultrasound wave traveling directly to the cardiac object and back to the transducer, the wave encounters a structure that acts as a wave refractor. This structure essentially behaves as a lens.⁴² As the wave goes through the structure, the path of the wave is bent at the interface, and the speed of the wave is changed depending on material of the structure. This results in duplication (often partial) of the cardiac object that appears as a sort of ghost image to the side of the true image (Figure 13). The produced image is similar to that of the mirror image artifact, but it appears next to instead of underneath the true image. Common inducers of refraction artifacts are costal cartilage, fascial structures and fat, and pleural and pericardial surfaces.^{43,44}

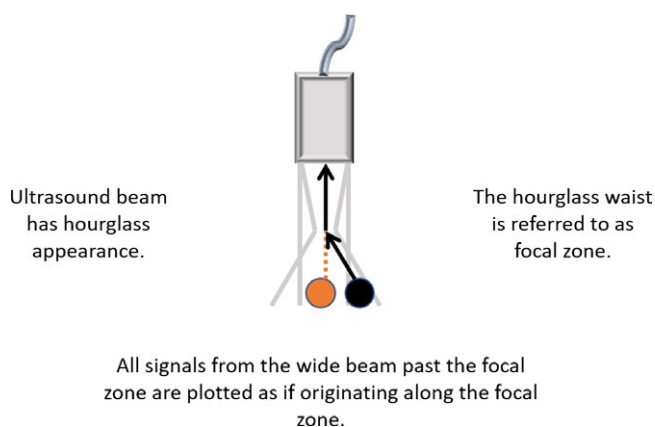
FIGURE 14 Cartoon demonstrating the mechanism behind beam width artifact

The beam width artifact violates that assumption that echoes are generated only from reflectors located within the main ultrasound beam. To comprehend this artifact better, one must understand the actual shape of the ultrasound beam. As the beam exits the transducer, it maintains approximately the same width as the transducer. It then narrows to a certain point (called the focal zone) and then widens again as it continues to move further from the transducer to a width often beyond that of the transducer.⁴⁶ This gives the ultrasound beam a sort of hourglass appearance (Figure 14). If there is a highly reflective object in the widened base of the beam, the ultrasound system will think that the echo from this object originates from the focal zone. Thus, ghost images of these highly reflective objects can become visible along the same plane of the real image.

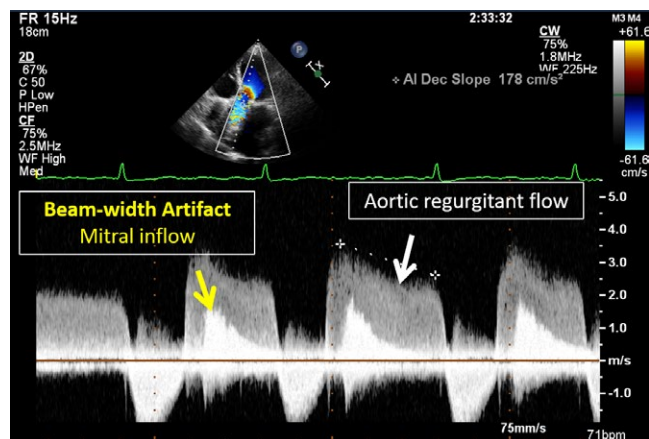
FIGURE 15 Beam width artifact of mitral inflow (yellow arrow) projected onto the aortic regurgitant flow (white arrow)

example is portrayed in Figure 15. The mitral flow is projected onto the aortic regurgitant flow, creating the illusion of a significant degree of aortic regurgitation. Confusion about valvular flow can lead to incorrect diagnoses and potentially unjustified surgery depending on the indication.

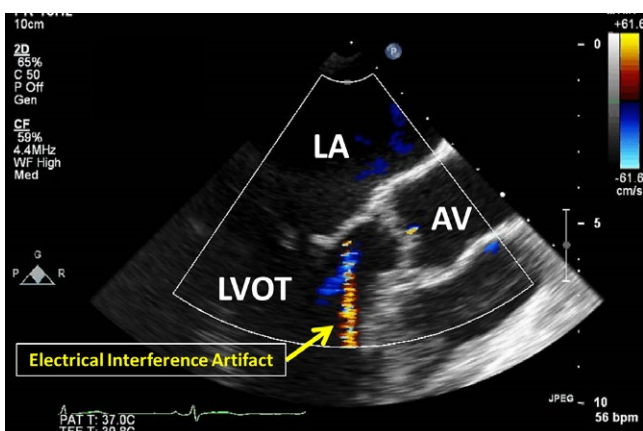
FIGURE 17 (Corresponds to Movie S13). Electrical interference artifact (yellow arrow) from unshielded electrical appliance or broken probe. AV = aortic valve; LA = left atrium; LVOT = left ventricular outflow tract

This artifact can be seen with a malfunctioning ultrasound probe, but it mainly occurs when other unshielded pieces of electrical equipment are turned on near the ultrasound machine. The external electronic signals are detected by the ultrasound system and these result in a band-like pattern over the normal ultrasound image.⁶⁰ This artifact is easily recognizable because it has a geometric shape and appears in all windows while the electrical equipment is still on or unshielded (Figure 17). Hence, there have not been any reported cases of this artifact leading to misdiagnoses.

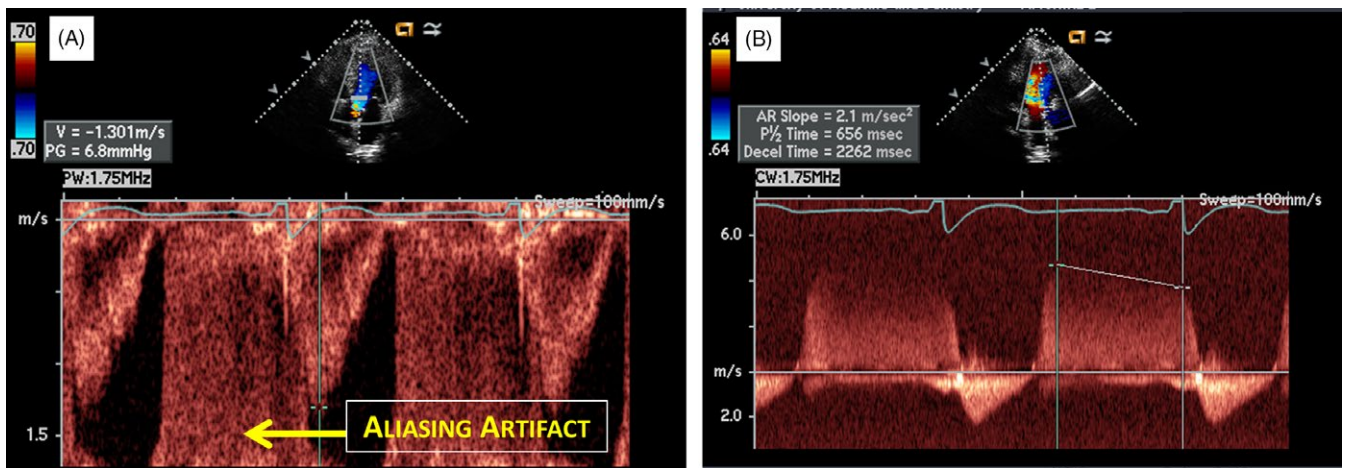
FIGURE 19 Panel A—Aliasing artifact (yellow arrow) of high-velocity aortic regurgitation jet on pulsed-wave Doppler. Panel B—Aliasing artifact eliminated with the use of continuous-wave Doppler

Aliasing artifacts are most commonly apparent in vessel and valvular stenosis. In these high flow states, the default PRF is usually set too low on spectral or color Doppler. Thus, the image shows flow reversal (Figure 19), which may confuse a clinician who is unaware of this artifact
